RE: *Shantell and Edward Hayes v. Regional Enterprises, LLC et al.*

On July 18, 2023 I traveled to the home purchased by your clients, Shantell and Edward Hayes (Sometimes as “Your Clients” and “Customers”), from our client, Regional Enterprises, LLC (“Regional”) for an inspection in Ethel, Louisiana prior to our mediation/arbitration of your clients’ claims. Your clients purchased a 2020 Deer Valley with Serial No. DVAL1200860AB (the “Home”) from Regional d/b/a McComb Home Center, a manufactured home retailer, on May 11, 2021

At the inspection, your clients had marked the alleged defects and/or issues with red tape. This report will examine each of your clients' allegations to identify whether these are manufacturing defects, lack of completion of the trim out of the home, or other issues.

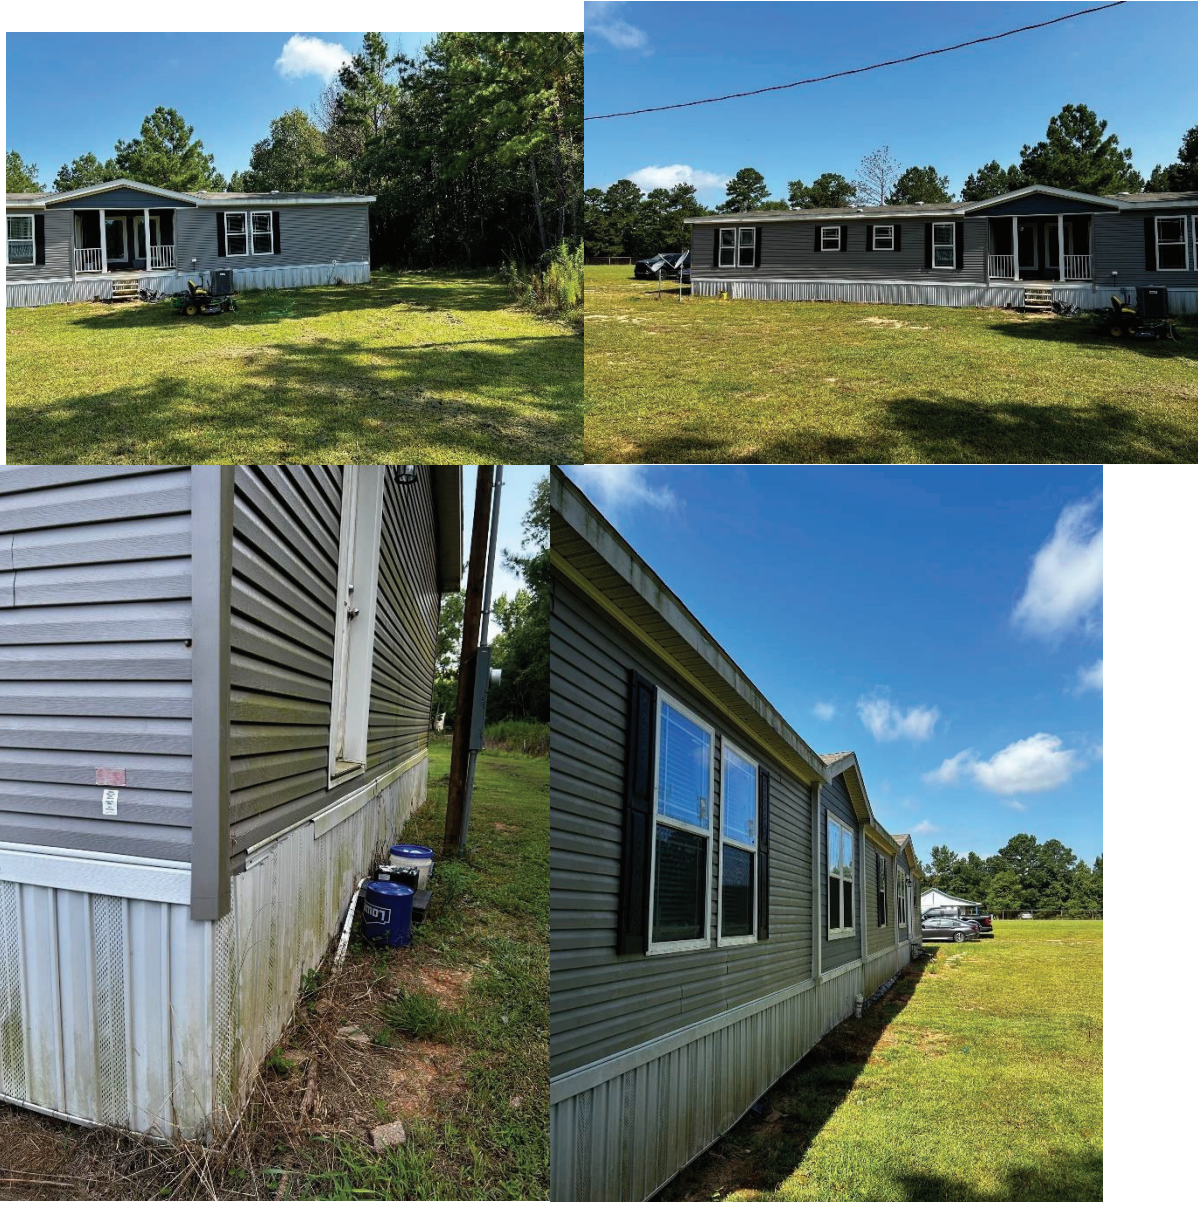
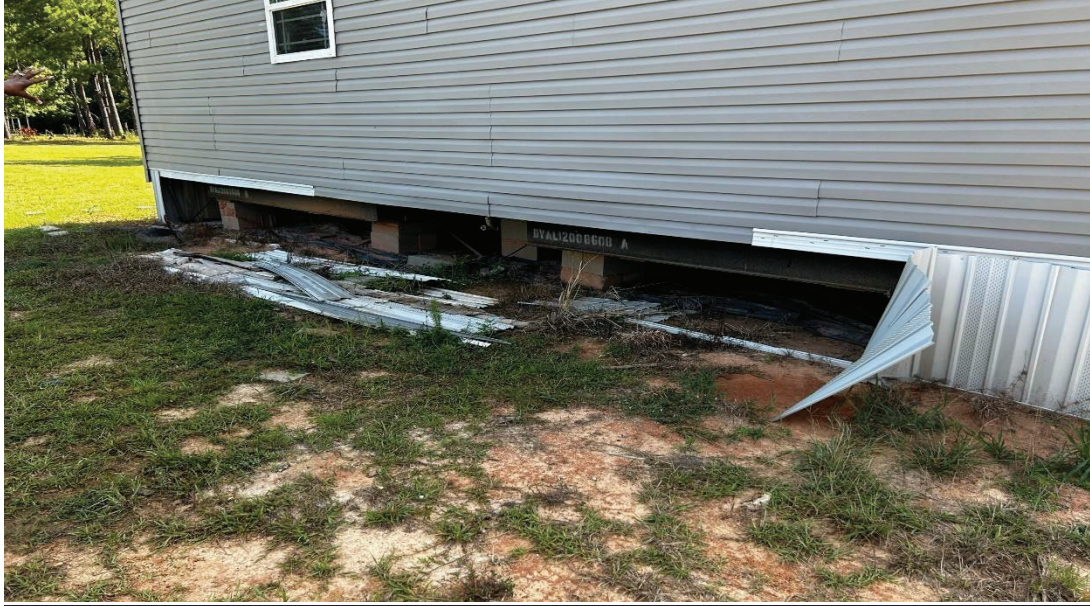
The skirting has never been put on the home.

- Skirting was on the home with the exception of one section, which, in the opinion of Regional, was removed by your clients or at their instruction. The materials were on the ground for that section and can easily be popped back into place.
